Technical Bulletin

Open female quick disconnect can cause coolant spillage

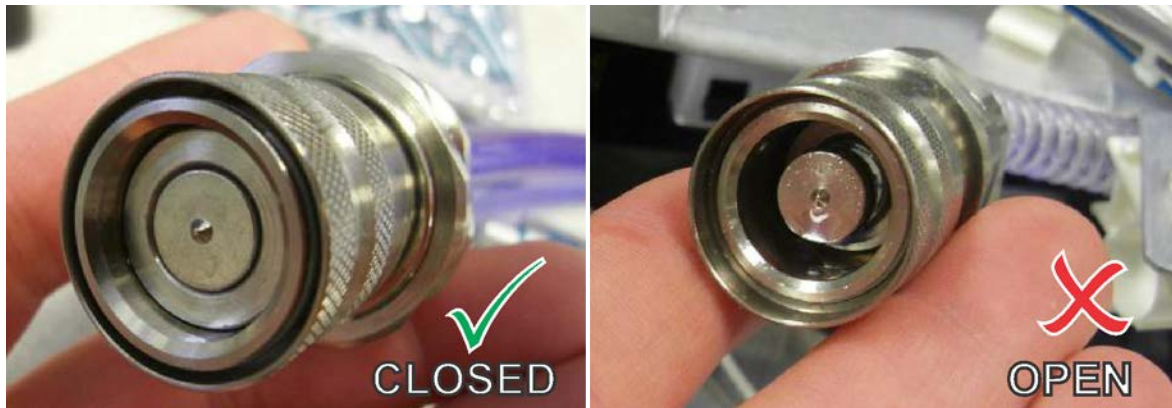
When disconnecting the liquid cooling system hoses, the inner locking ring of the female-side of the quick disconnect may become stuck in an open position (as illustrated below). Coolant may spill and enter the fold mirror or integrator assemblies, which can result in difficult cleanup operations.

1. Position yourself for appropriate visibility of the female disconnect end face.
2. Capture coolant that may spill from the female disconnect (side that the release ring slides toward).

To prevent coolant from entering the fold mirror and integrator assemblies, place additional absorptive cloths on top of these areas. Once the female-side is disconnected, point it upright to reduce the amount of coolant loss if the inner locking ring becomes stuck.

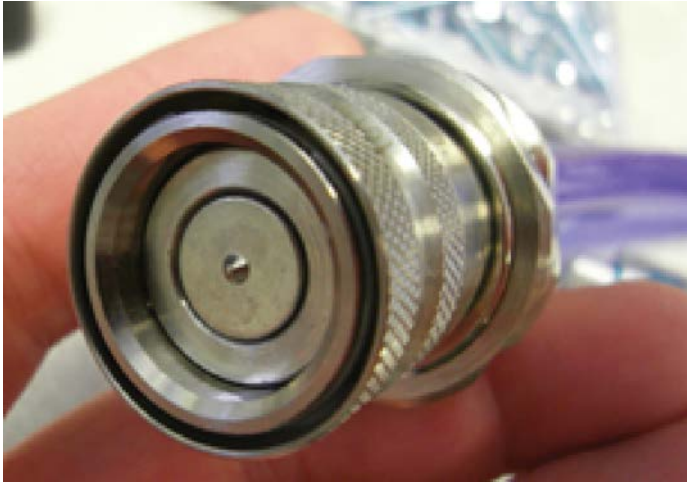
As the female ring releases and moves to its closed position under spring load, it can cause some coolant to be ejected.

1. Immediately re-insert the male disconnect to stop the coolant spill.
2. Wiggle the connection and attempt to disconnect again.
3. If the female disconnect still does not close properly, ensure the coolant has been fully captured and has stopped flowing.
4. Use a soft tipped tool, which can fit inside the connection to press down gently on the stuck ring until it releases and properly closes.
